BORG-WARNER CORPORATION

ADHESIVE BONDING OF END CLOSURES FOR HIGH STRENGTH AND RELIABILITY IN ROCKET MOTOR CASES

Quarterly Report No. 3 Contract NOrd 15719 Control 2937-62 October 1, 1962 through March 30, 1963

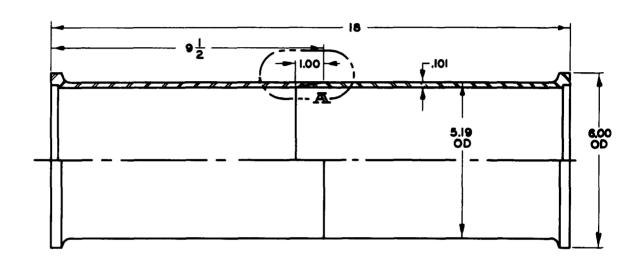
Figure 1. Sub-Scale Bonded Joint Test Case for Biaxial Loading

The design of the sub-scale cases is shown in Figure 1.

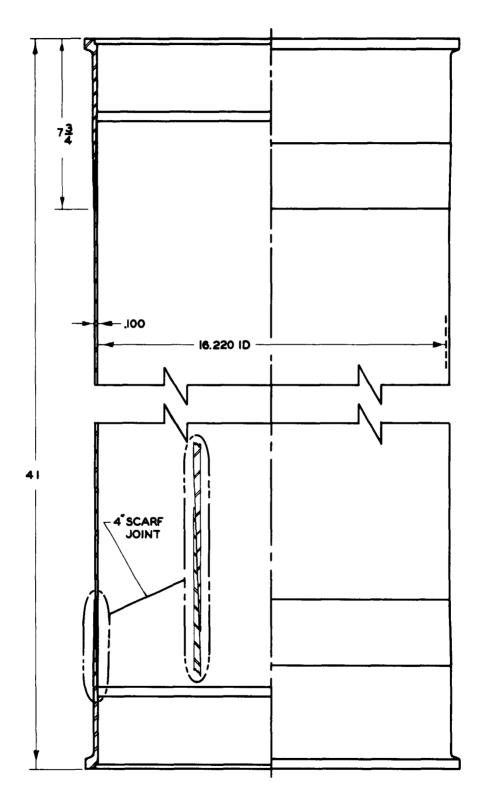
Figure 4. Basic Tube Design for Bonded End Ring Case

The case design for the 16" nominal diameter bonded joint prototype cases is shown in Figure 4.

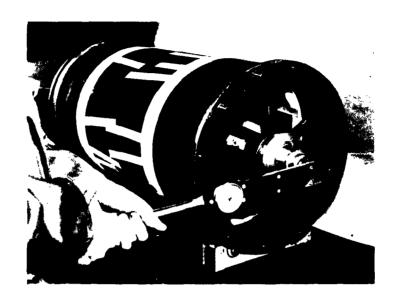
Figure 11. The End Rings Were Drawn onto the Tubular Section Using the Threaded Rod and End Plate Curing Fixture and Wrench.

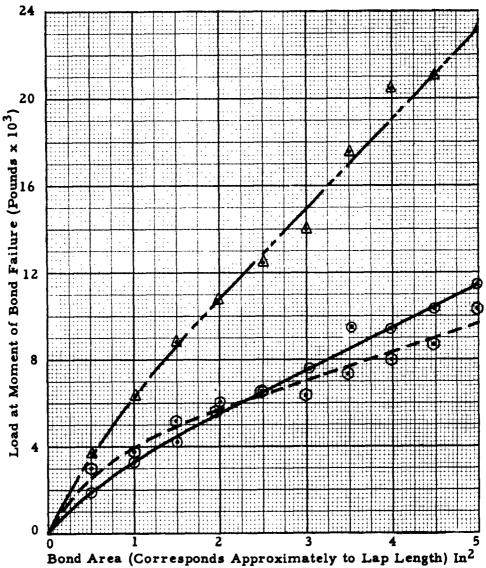
Each point represents the mean value of five samples. Uniaxial lap shear samples were one inch wide with various lap lengths. The load corresponds to the longitudinal load per inch of periphery in a cylinder. The slope of the curve gives the unit lap shear stress.

Figure 14. Load vs. Bonded Area for Various Lap Lengths

It was evident that to solve the remaining problem, assuring failure of the bonded joint rather than the case wall, the bonded joint would have to be weakened. This was done to all succeeding cases by reducing the scarf joint length from 4" to approximately 2-1/4". The original goal of the program was to fabricate bonded joints having shear strengths of 3750 psi over each inch of the 4" long joint for a total strength of 15,000 pounds per peripheral inch. With the joint length reduction from 4" to 2-1/4" it would not be possible to achieve the latter figure, however the former figure, 3750 psi, could still be achieved regardless of joint length. It was reasoned that If 3750 psi shear strength could be attained over a joint length of 2-1/4" then, with a stronger and/or less notch sensitive case material, it could also be attained over a joint length of 4". This would be basically true only if bonded joint strength were directly proportional to joint length within the 2" to 4" range. Reference is made to Figure 14. This graph of joint strength versus joint length for FM-1000 adhesive was published by IKD in Quarterly Report Number 5, dated 15 January 1962 for Feltman Research and Engineering Laboratories, Picatinny Arsenal, Dover, New Jersey under Contract DA-20-018-ORD-22890. It shows that the function between these two variables in the 2 to 4" range is a straight line. The inference then was that if the unit shear strength of 3750 psi could be achieved on the shorter joint it would at least indicate that the original target strength of 15,000 pounds per peripheral inch could also be achieved.

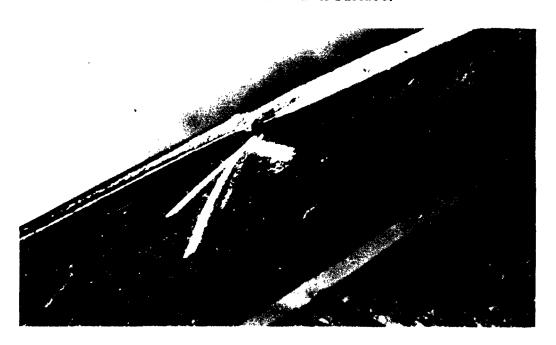
Figure 20. Super Tricent Case #3 Plain stress originates from a crack at the inner wall surface
